# Inspection Report

**Property Address:**  
3851 NE 22\*\*  
Unit 17  
Lighthouse Point FL 33065

<b>Date:</b> 10/29/2012	<b>Time:</b> 4:30 PM	<b>Report ID:</b> 1201
<b>Property:</b> 3851 NE 22** Unit 17 Lighthouse Point FL 33065	<b>Customer:</b> John Smi**	<b>Real Estate Professional:</b>

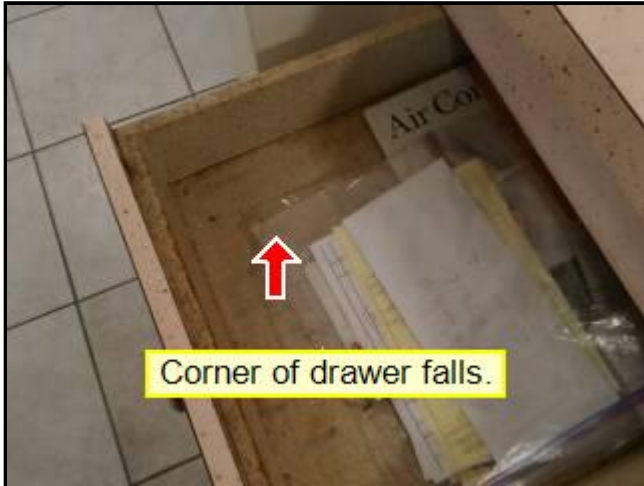
1.5 Picture 1 Drawer to left of range.

**1.5** The cabinets are on the older side and show some age. The drawer is broken as shown in the image. The cabinet under the sink shows signs of old water damage. No current water problem at the time of inspection. Simple repair can be done for about \$50.00-\$100.00(Picture 1)

The cabinets are on the older side and show some age. The drawer is broken as shown in the image. The cabinet under the sink shows signs of old water damage. No current water problem at the time of inspection. Simple repair can be done for about \$50.00-\$100.00(Picture 1)

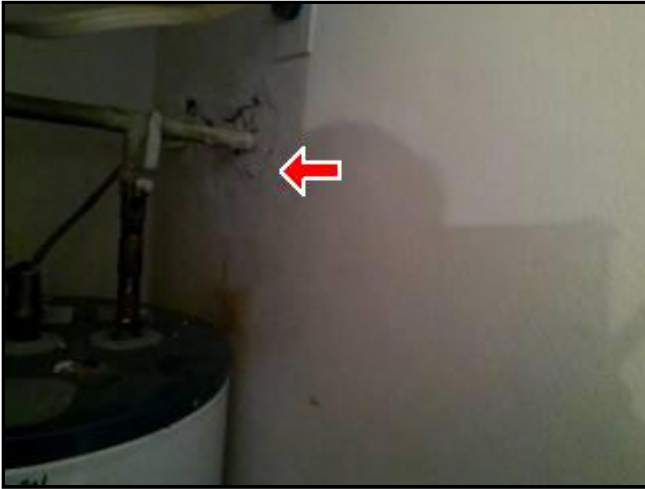
2.1.A Picture 1

**2.1.A** The utility closet is located just off of the main living area. There is some miscellaneous patching around the water heater.

The utility closet is located just off of the main living area. There is some miscellaneous patching around the water heater.

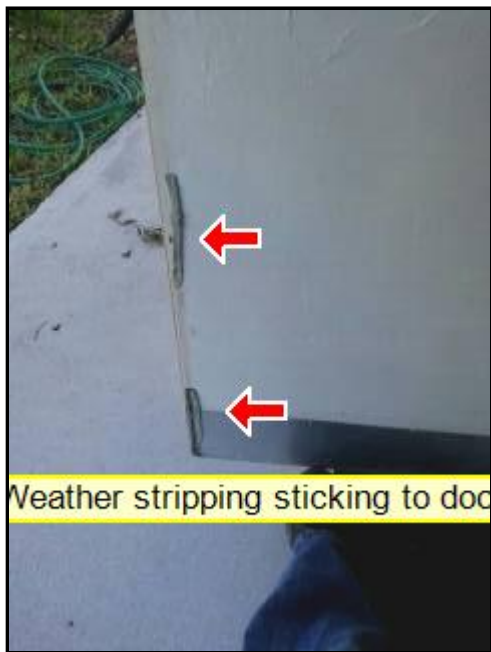
2.3.A Picture 1

**2.3.A** Weather stripping is very important to energy savings. If weather stripping is not in good condition, you will be letting conditioned air out and heat in. Weather stripping is a typical maintenance item and easy to install.

Weather stripping is very important to energy savings. If weather stripping is not in good condition, you will be letting conditioned air out and heat in. Weather stripping is a typical maintenance item and easy to install.

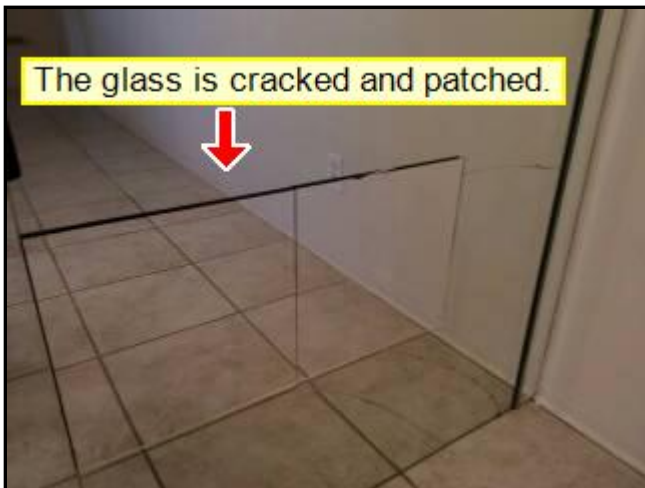
2.1.B Picture 1

**2.1.B** The glass wall seems to have been previously patched and needs to be replaced.

The glass wall seems to have been previously patched and needs to be replaced.

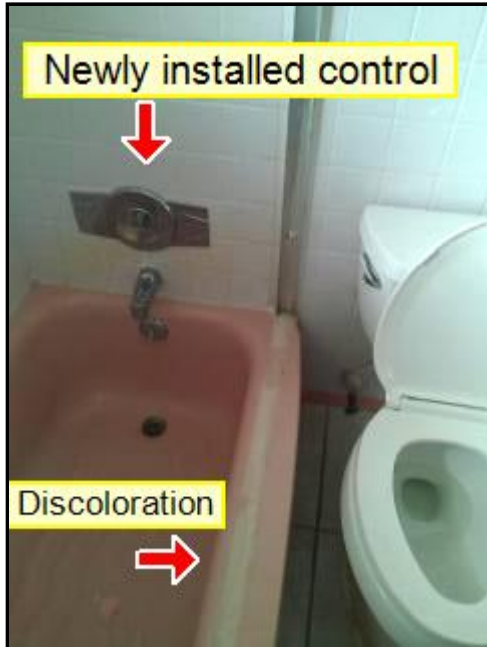
**2.5.D** The Master Bathroom was located just outside of the master bedroom. The bathtub use to have a sliding glass door that was partially removed and left discoloration. The bathtub control is not original and when it was replaced it was not installed correctly. One of the screws is not in and affects the ability to use the control valve. It was also found that the outlet in the bathroom had an object stuck in the ground hole. This outlet should also be replaced with a GFI since it is close to a water source. Lastly the cabinet doors need to be realigned to close correctly.

2.5.D Picture 1 Master bathtub.

The Master Bathroom was located just outside of the master bedroom. The bathtub use to have a sliding glass door that was partially removed and left discoloration. The bathtub control is not original and when it was replaced it was not installed correctly. One of the screws is not in and affects the ability to use the control valve. It was also found that the outlet in the bathroom had an object stuck in the ground hole. This outlet should also be replaced with a GFI since it is close to a water source. Lastly the cabinet doors need to be realigned to close correctly.

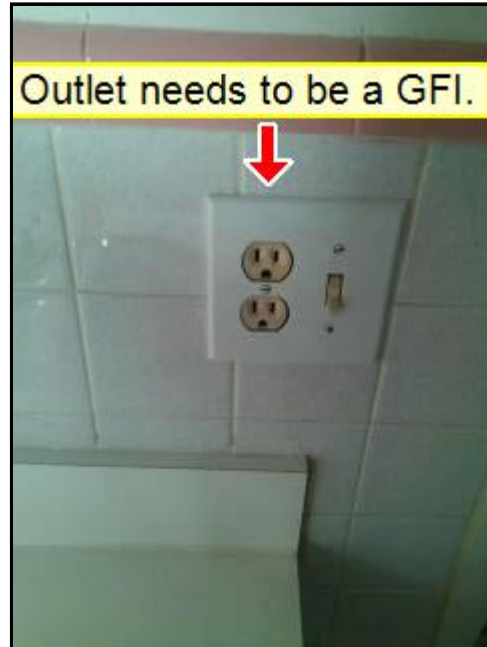
2.5.D Picture 2 Master Bath outlet.

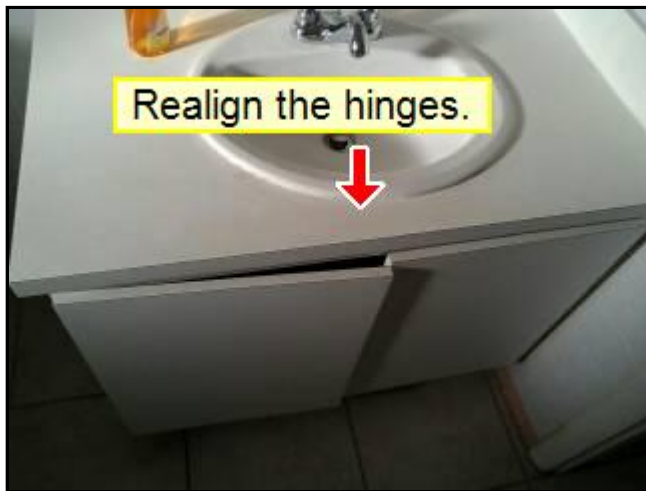
2.5.D Picture 3 Master Bath cabinet.

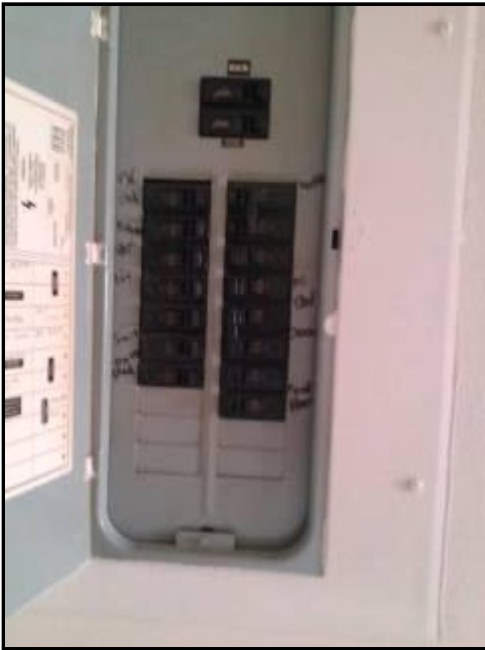
4.0 Picture 1

**4.0** The existing panel seems to be well labeled. We did not find any GFI circuits in the home. This could be due to the age and the building codes at the time the unit was built.

**4.1** As noted earlier no GFI circuits are in the unit. One GFI should be added to the kitchen and the bathroom.
